BULGARIAN FIGHTER COLOURS 1919–1948

Vol. 1

Rainbow No 9136

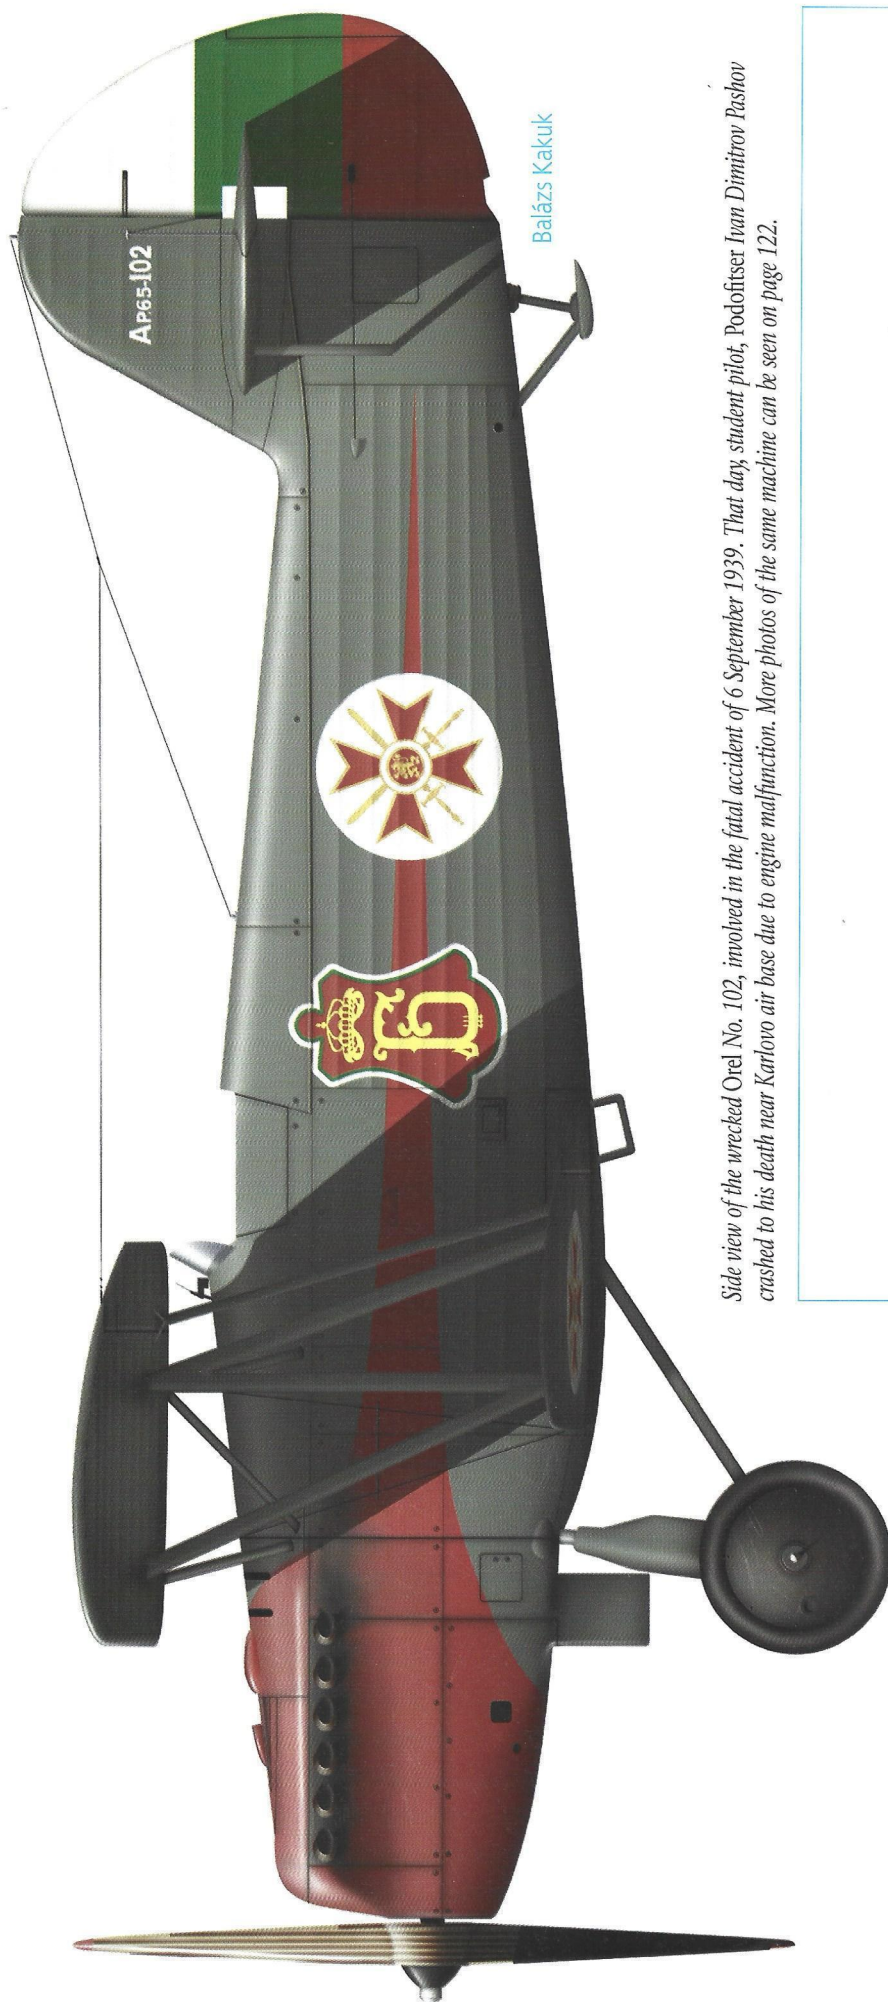
Side view of the wrecked Orel No. 102, involved in the fatal accident of 6 September 1939. That day, student pilot, Podofitser Ivan Dimitrov Pashov crashed to his death near Karlovo air base due to engine malfunction. More photos of the same machine can be seen on page 122.

The only fatal accident involving an Orel happened on 6 September 1939. That day, aircraft No. 102 crashed near

Karlovo air based due to engine malfunction, killing the student pilot, Podofitser Ivan Dimitrov Pashov.

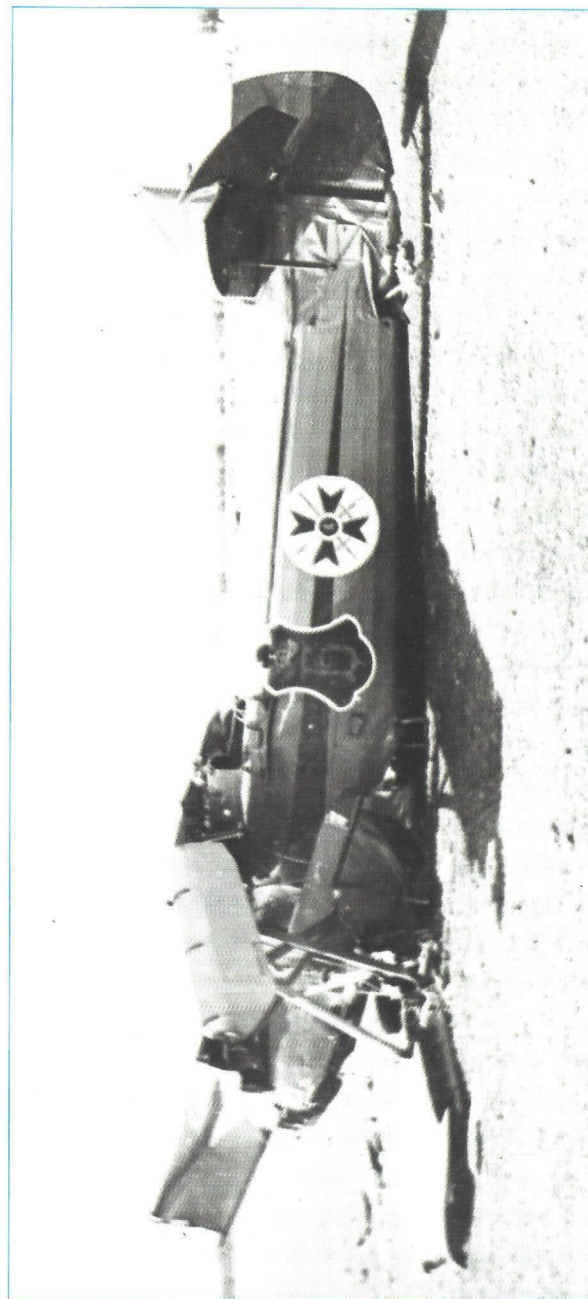
Arado Ar 65F Orel, 2/7027, No. 102, Shkola za vissh pilotazh, Podofitser Ivan Dimitrov Pashov, Marno Pole/Karlovo airfield, 6 September 1939. Camouflage colour: Light Grey (DKH L 40/52, later RLM 63; or RLM 02) overall. Engine cowling Red all around, extended rearwards by a tapering horizontal flash along the fuselage. Early style VNVV military marking in six positions. 'Royal cipher' on mid-fuselage. Aircraft type and serial number on mid-fin in White. White-Green-Red rudder.

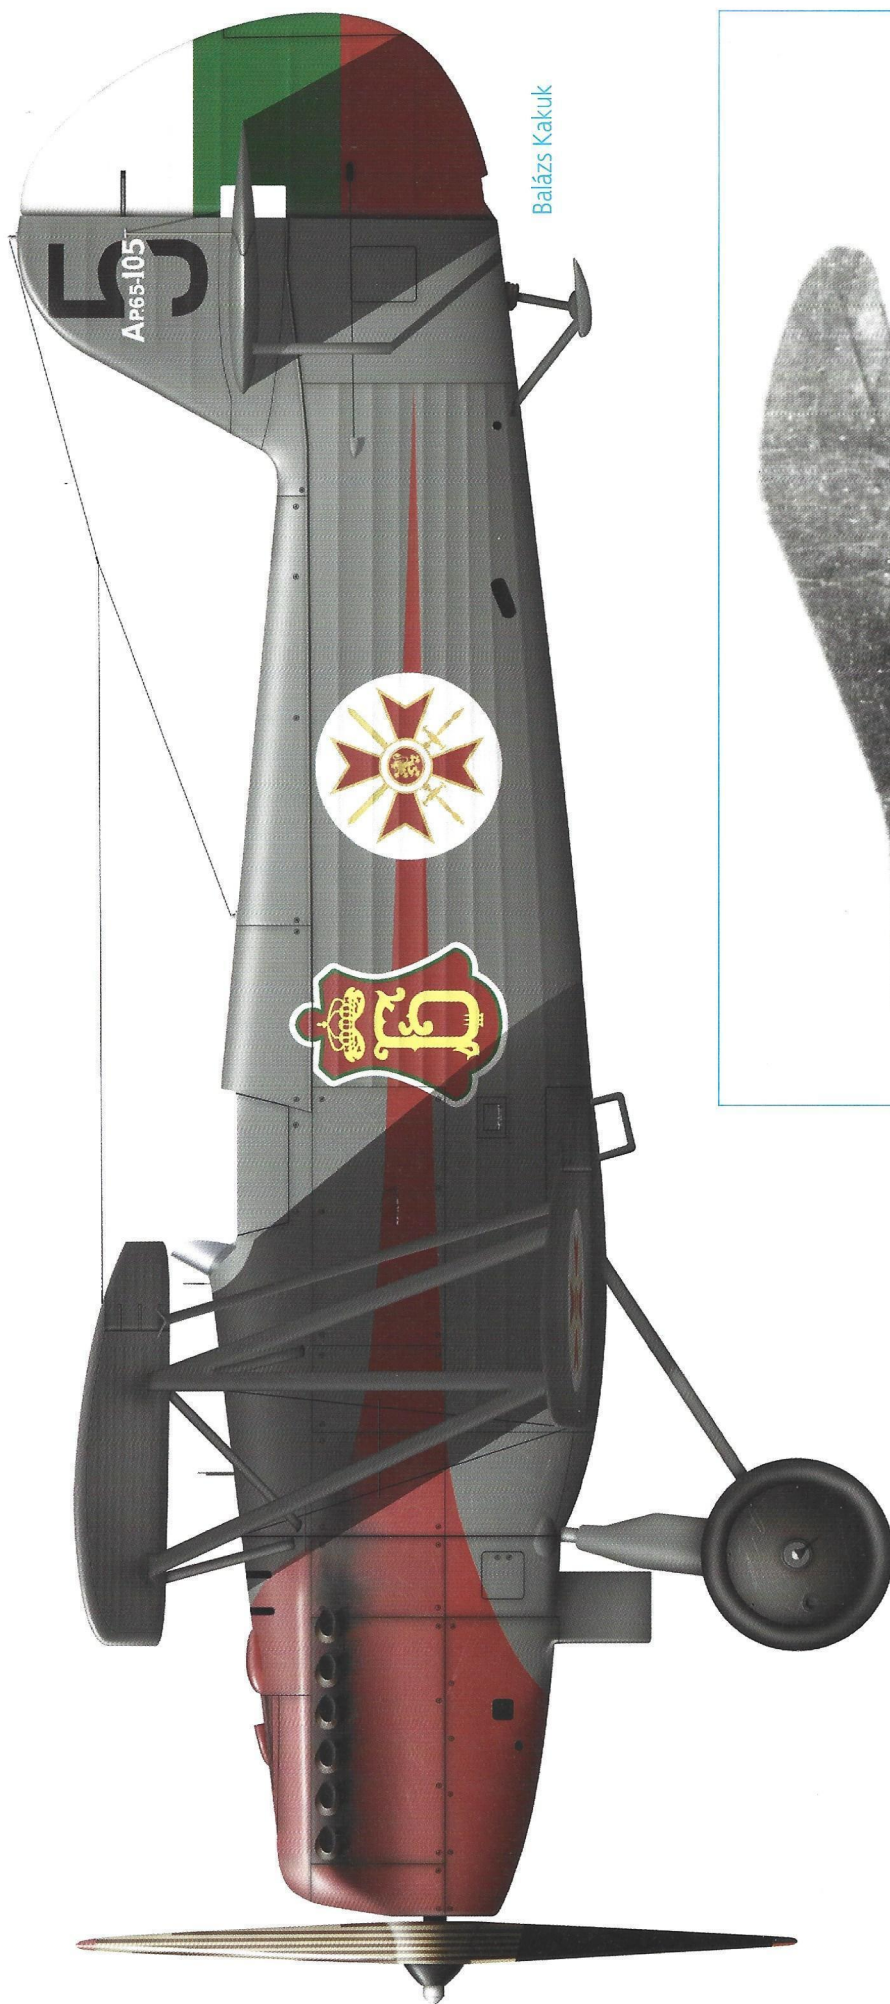
Arado Ar 65F Orel, 5/7027, No. 105, 'Black 5', *Skola za visih pilotazh*, Marno Pole/Karlovo airfield, late 1939. Camouflage colour: Light Grey (DKH L 40/52, later RLM 63; or RLM 02) overall. Engine cowling Red all around, extended rearwards by a tapering horizontal flash along the fuselage. Early style VNVV military marking in six positions. 'Royal cipher' on mid-fuselage. Aircraft type and serial number on mid-fin in White. Last digit of the serial number repeated in black, also on fin. White-Green-Red rudder.

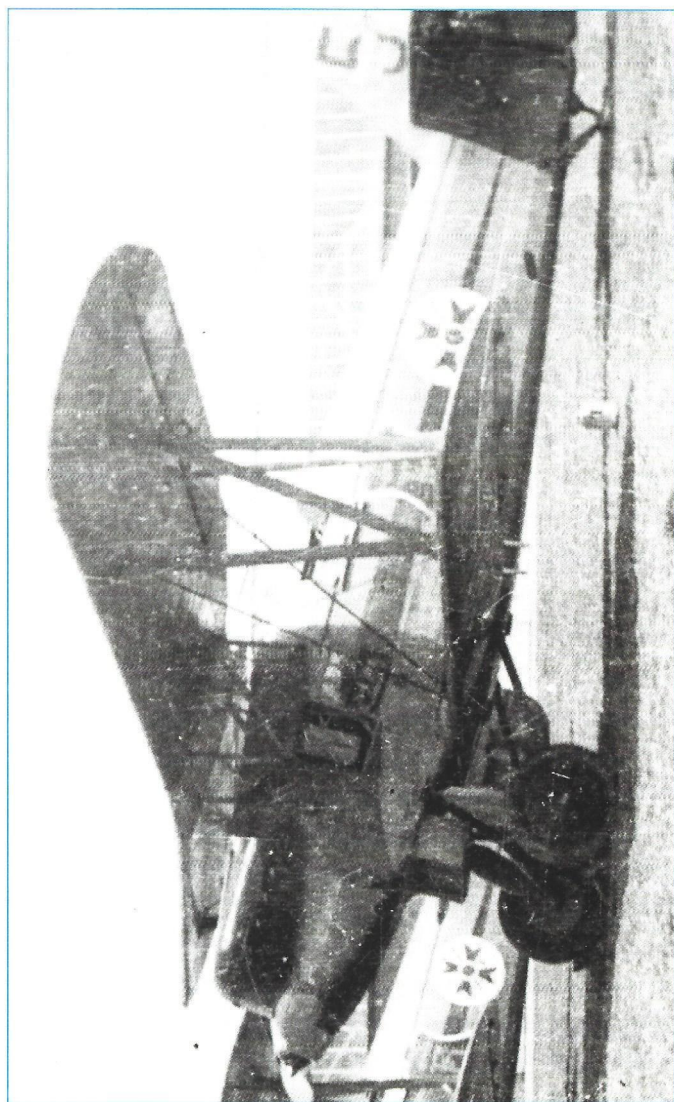
Detail of a larger photo (see page 127) showing a row of Ar 65Fs lined up on Marno Pole/Karlovo airfield in late 1939, including No. 5. All features characteristic of the early livery worn by the Arado fighter trainers are visible (for details see Colours and Markings sub-chapter). The only exception is the individual number, applied in large black character on fin, contrary to Order No. 53/14.04.1938, which stipulated that the number should be applied on the white area of the rudder.

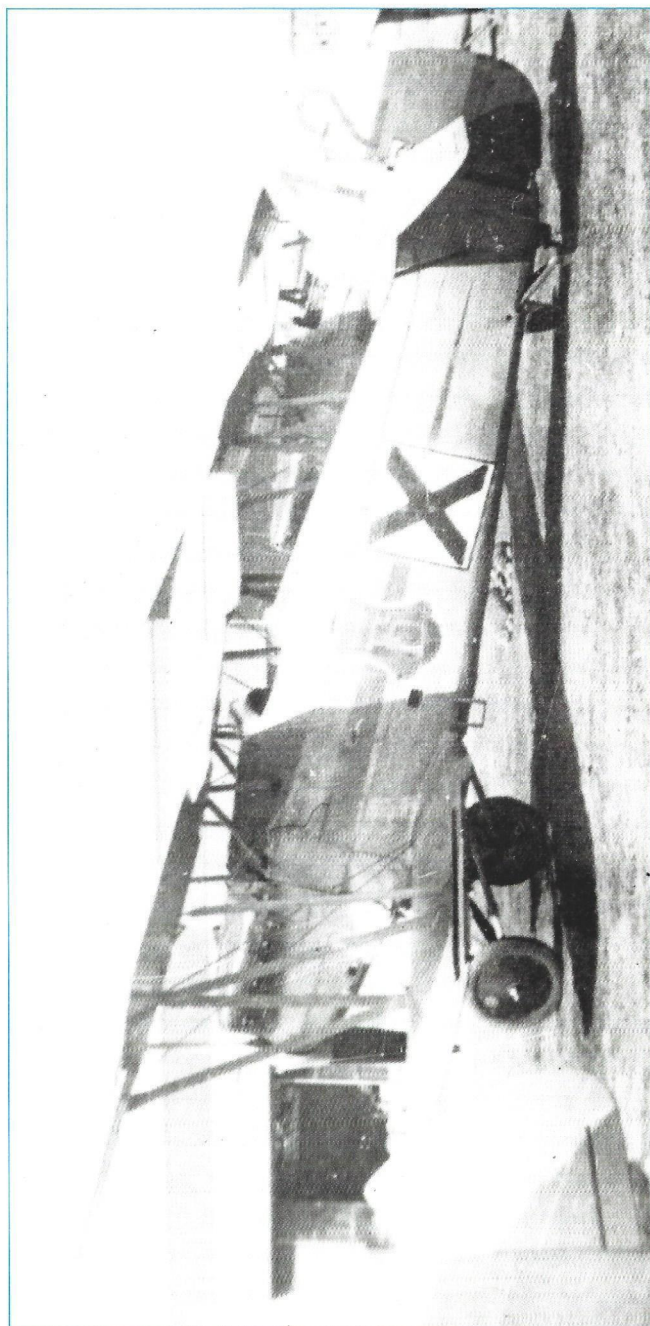
Detail photo of 'Black 12', parked on Marno Pole/Karlovo main air base in late summer of 1940. (The complete photo can be seen on page 128).

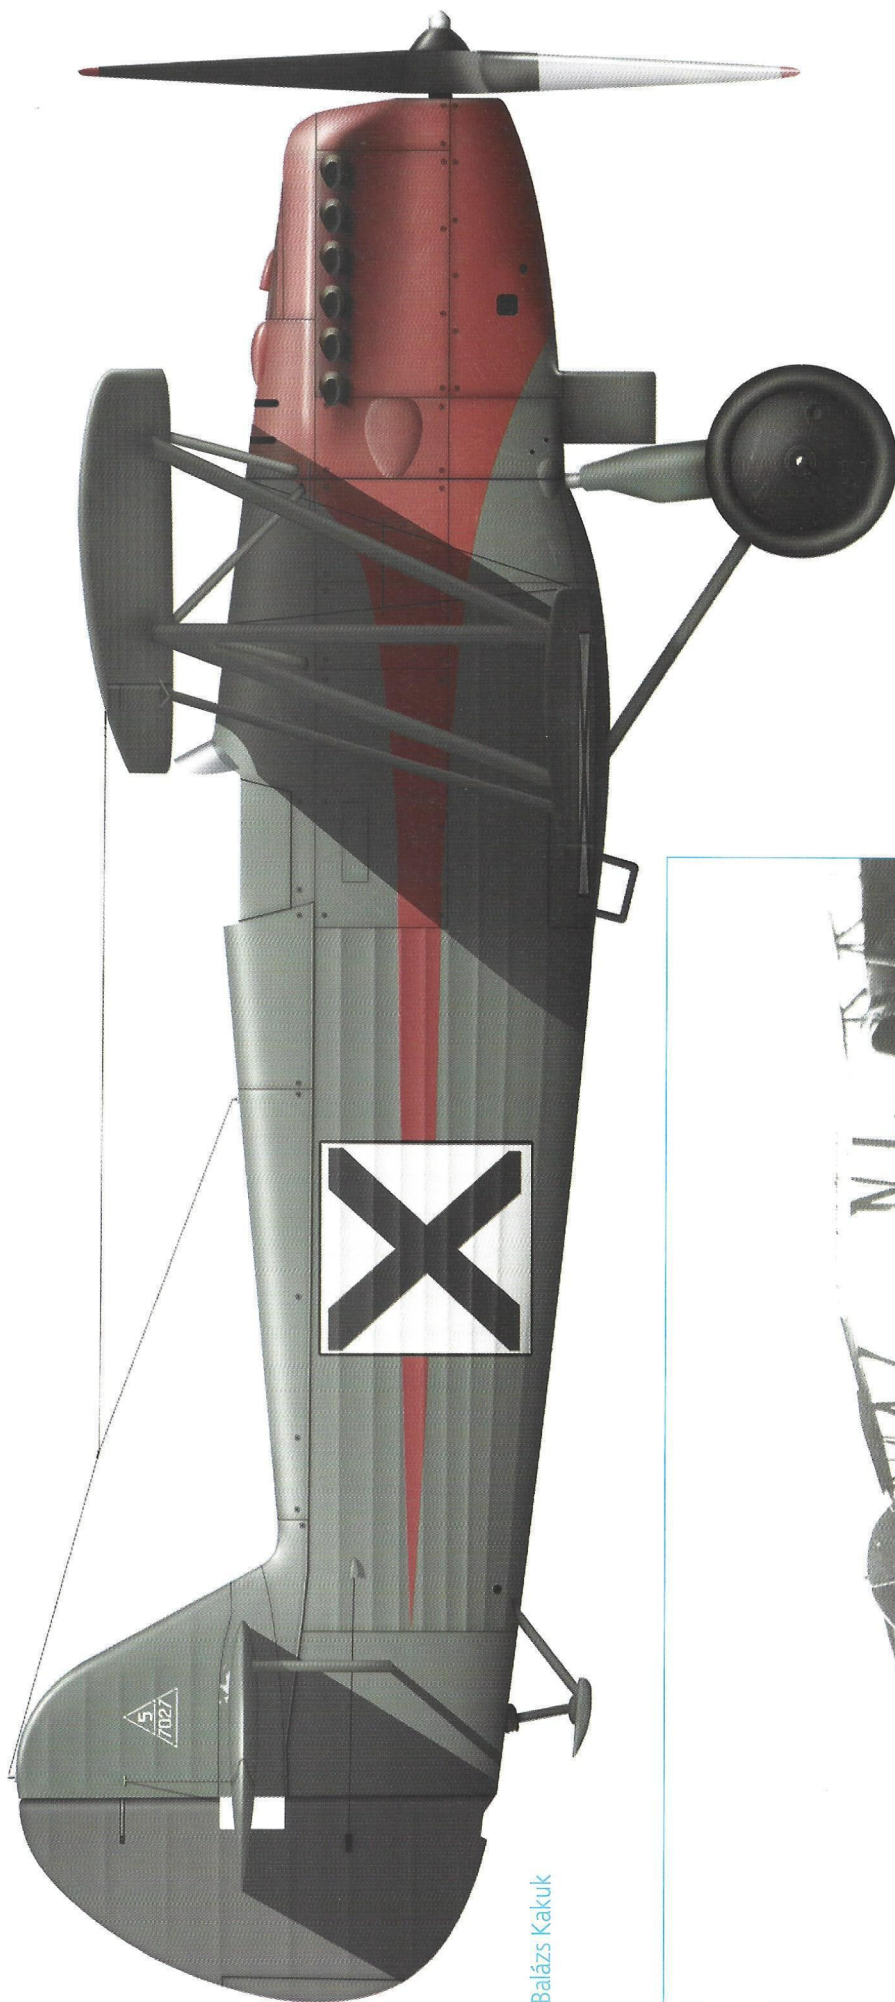
Arado Ar 65F Orel, 12/7027, No. 112, 'Black 12', Shkola za vissh pilotazh, Marno Pole/Karlovo airfield, late summer of 1940. Camouflage colour: Light Grey (DKH L 40/52, later RLM 63; or RLM 02) overall. Engine cowling Red all around, extended rearwards by a tapering horizontal flash along the fuselage. Axis style VNVV military marking in six positions. 'Royal cipher' on mid-fuselage. Aircraft type and serial number on mid-fin in White. Last two digits of the serial number repeated in black, on fin and rudder. White-Green-Red rudder.

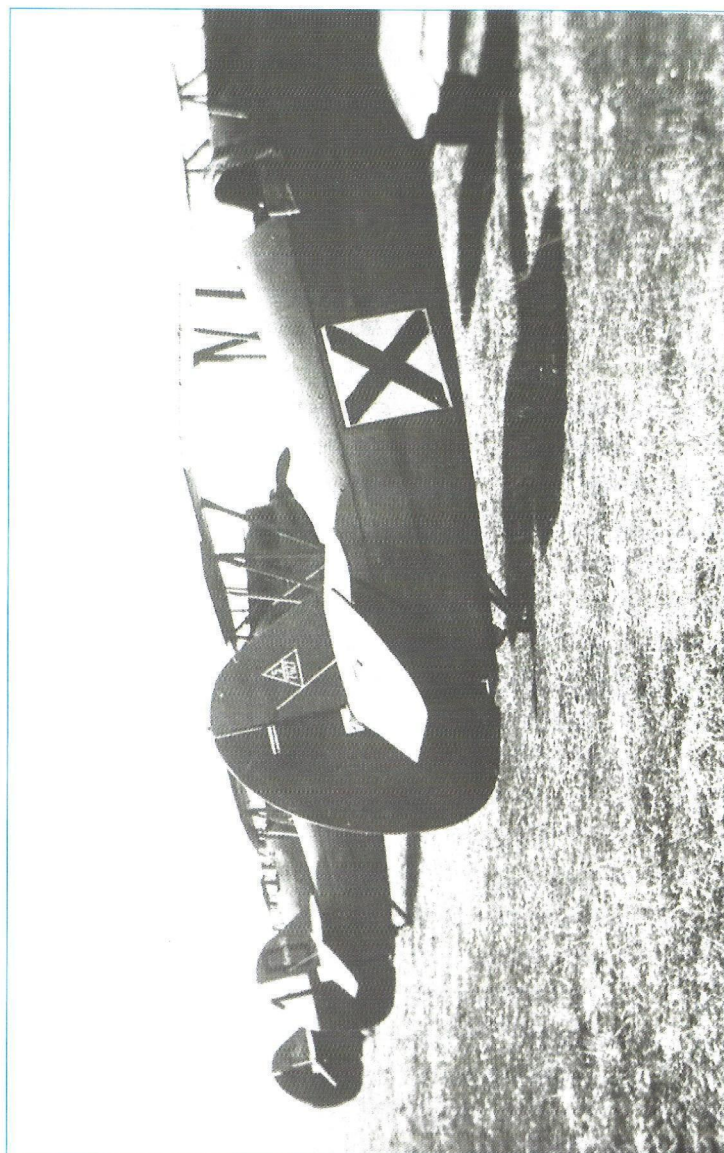
Two different tail marking styles can be observed on these lined up Arado Ar 65F's. In centre, Orel No. 10 still sports the early war high-visibility tail marking. By contrast, the two Orels seen in front and rear already sport low visibility tail (aircraft No. 5/7027 is closest to the camera). Photo taken on the landing ground of Marno Pole/Karlovo in the Autumn of 1941.

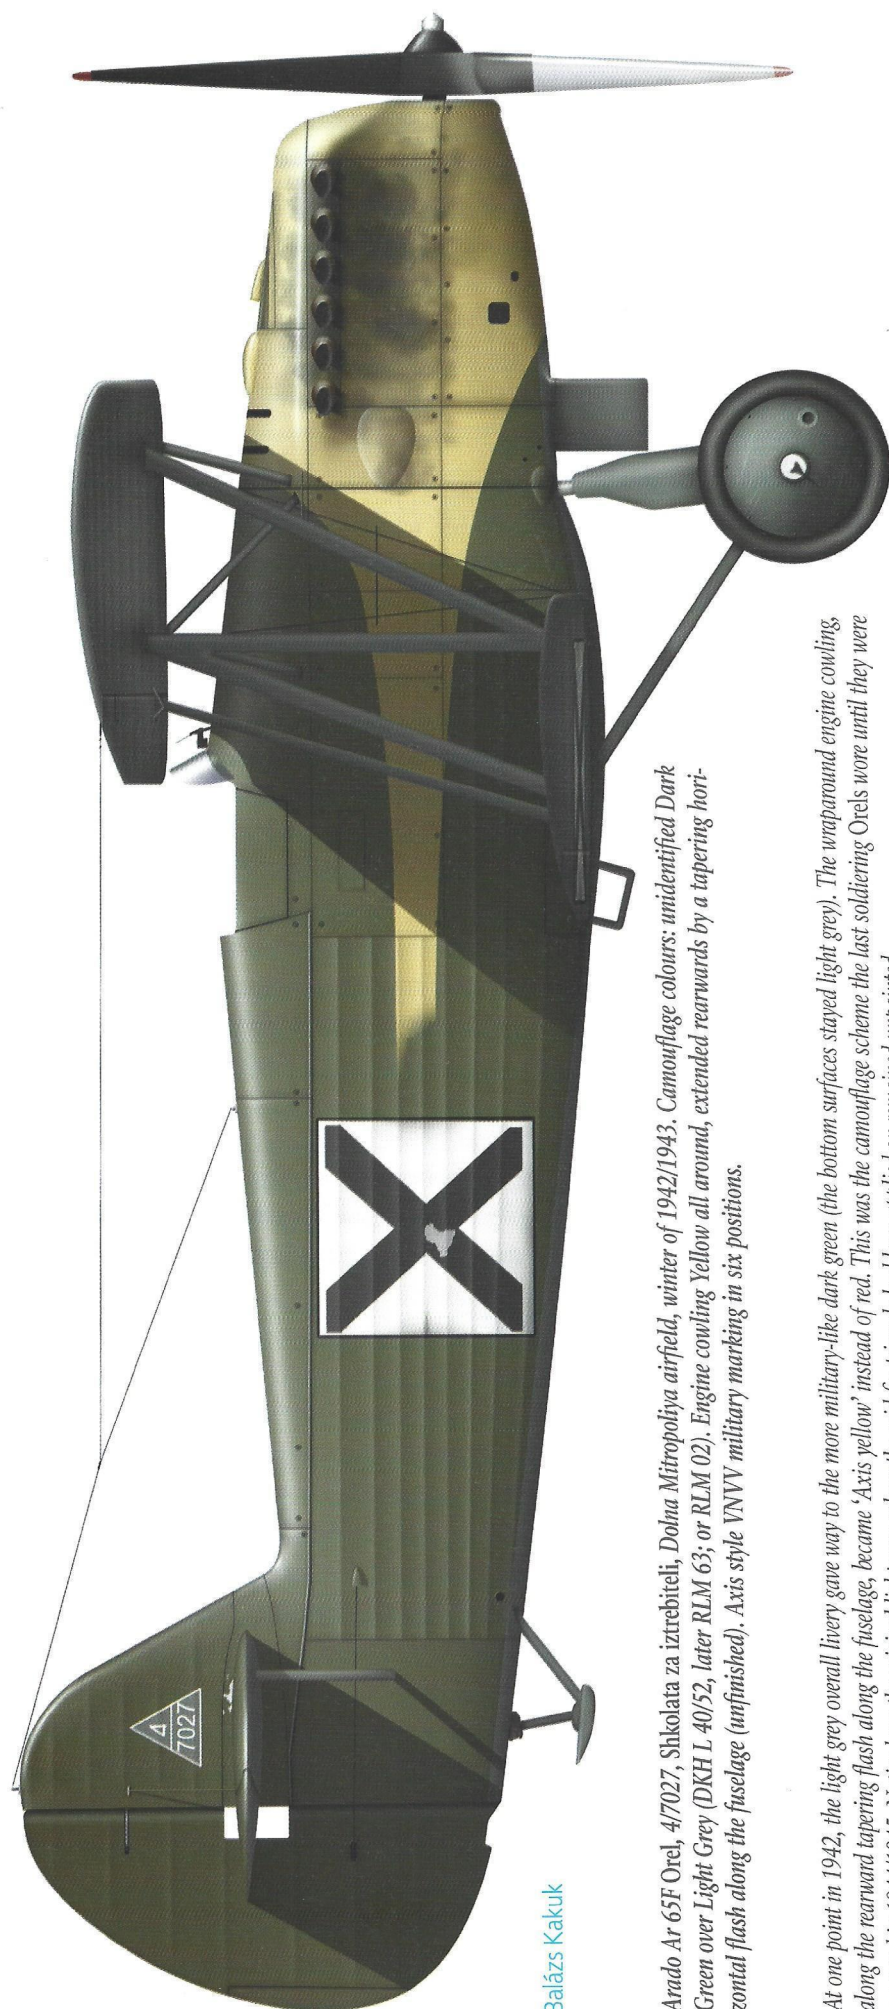
Arado Ar 65F Orel, 4/7027, Shkolata za iztrebiteli, Dolna Mitropoliya airfield, winter of 1942/1943. Camouflage colours: unidentified Dark Green over Light Grey (DKH L 40/52, later RLM 63; or RLM 02). Engine cowlings Yellow all around, extended rearwards by a tapering horizontal flash along the fuselage (unfinished). Axis style VNVV military marking in six positions.

At one point in 1942, the light grey overall livery gave way to the more military-like dark green (the bottom surfaces stayed light grey). The wraparound engine cowlings along the rearward tapering flash along the fuselage, became 'Axis yellow' instead of red. This was the camouflage scheme the last soldiering Orels wore until they were scrapped in 1944/1945. Notice how the original light grey colour the mid-fin triangle had been applied on remained unpainted.

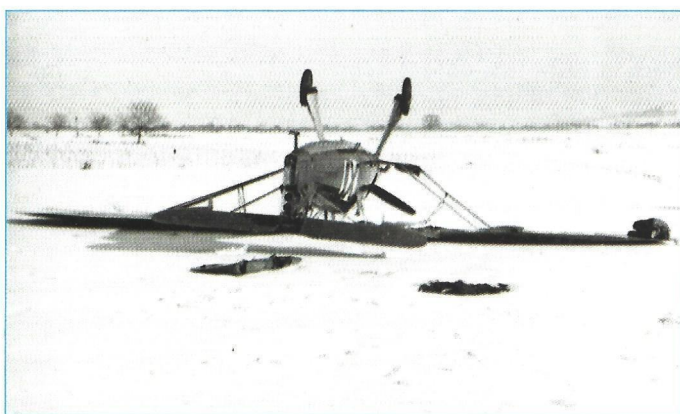
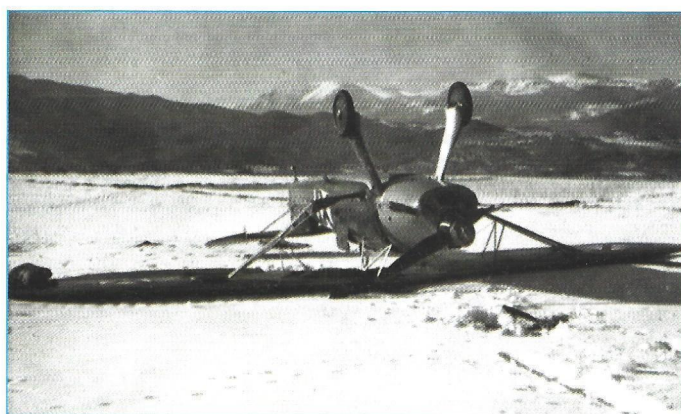
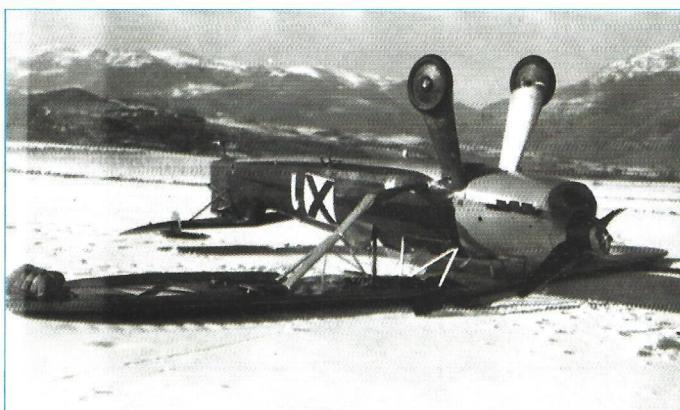
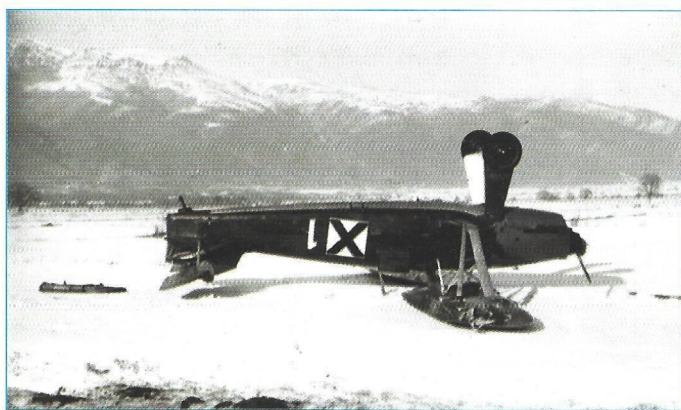
On 16 February 1943, Poruchik Nikola Vălchev of the 6th Fighter Regiment was flying Komar No. 1 on a routine flight from Marno Pole to Kazanlāk, when the engine quit in mid-air. The pilot tried to land with his powerless aircraft; however, it turned over upon attempting to taxi in thick snow. The wing under surface looks very dark, in contrast to the clearly light blue painted wing struts. This is not in line with the other photos that show it as painted in a shiny light colour.

The sole accident we have details about happened on 16 February 1943. *Poruchik* Nikola Vălchev of the 6th Fighter Regiment was flying *Komar* 1/7003 on a routine flight from Marno Pole to Kazanlāk, when the engine quit in mid-air, at around 11:30. The pilot tried to land with his powerless aircraft; however, it turned over upon attempting to taxi in thick snow south of Kazzanlāk. The pilot was lucky, as he escaped alive. Based on the post-accident photos, the aircraft was repairable. (See photos on the bottom of the page).

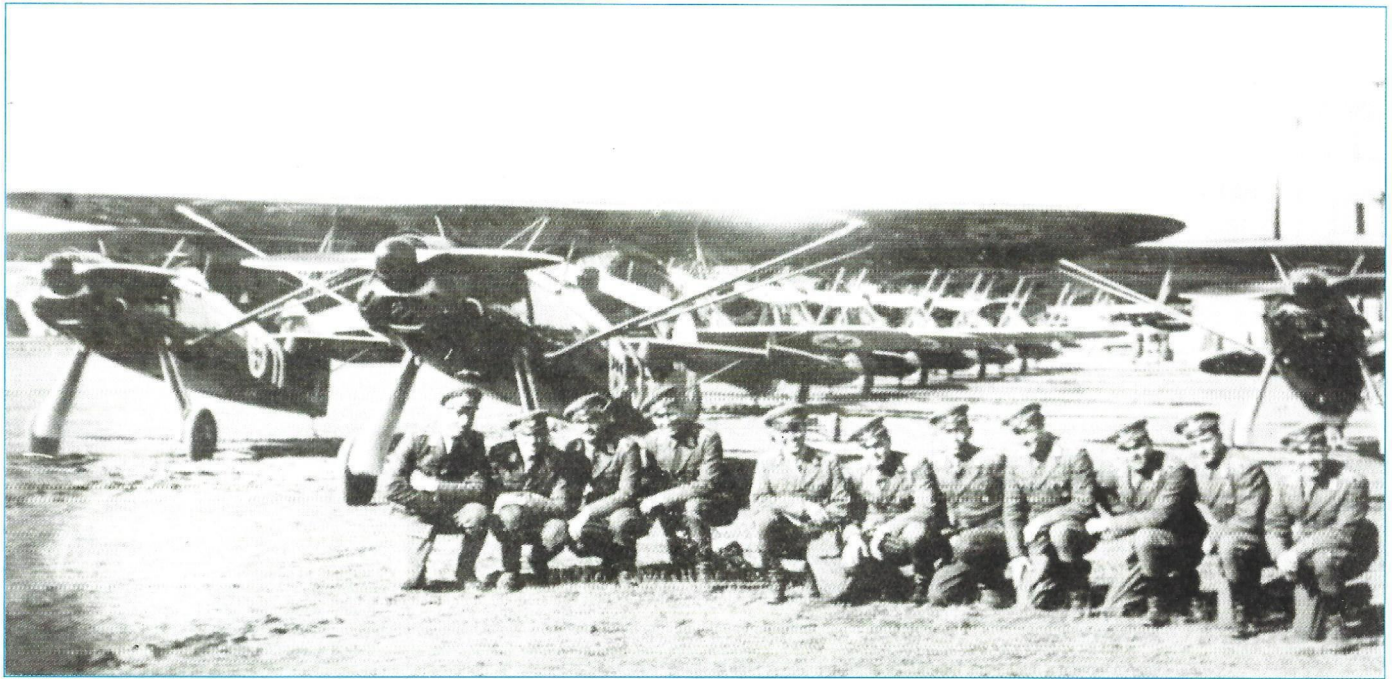
Line-up of Heinkel He 51 fighter biplanes, led by a Focke-Wulf Fw 56 trio, in preparation for one of the many parades. In centre, Komar No. 33-10, is visible. Eleven fighter pilots – some faces being familiar, often seen on other photos – casually pose for this shot taken at Bozhurishte airfield, in 1939.

No. 33-10 was the last aircraft of the Fw 56 pair in the third squadron. A couple of fighter aircraft types using the same numbering style⁶ were the PZL P.24 *Yastreb* (tail numbers from 1 to 4) and the Heinkel He 51 *Sokol* (tail numbers from 5 to 8).

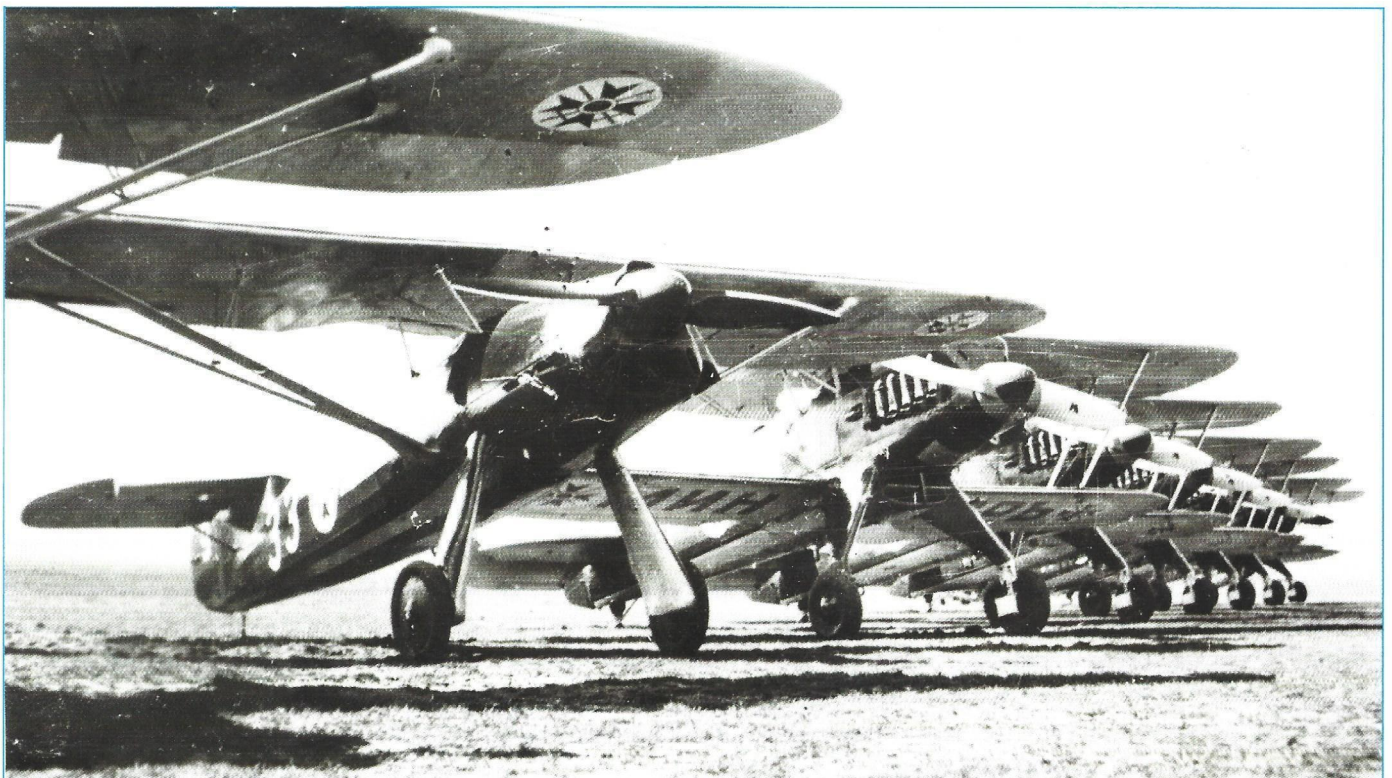
Another line-up led by two Fw 56s, also in company of He 51s, six of them. Although the identity of the Komar, 33-9, is apparent, the He 51 near it can be identified only by its unique writing on the lower wing's undersurface: мин on the starboard and борЪ on the port side. When read together, it means Miner, and was written in honour of the coal miners of Pernik, who reportedly paid for the aircraft.

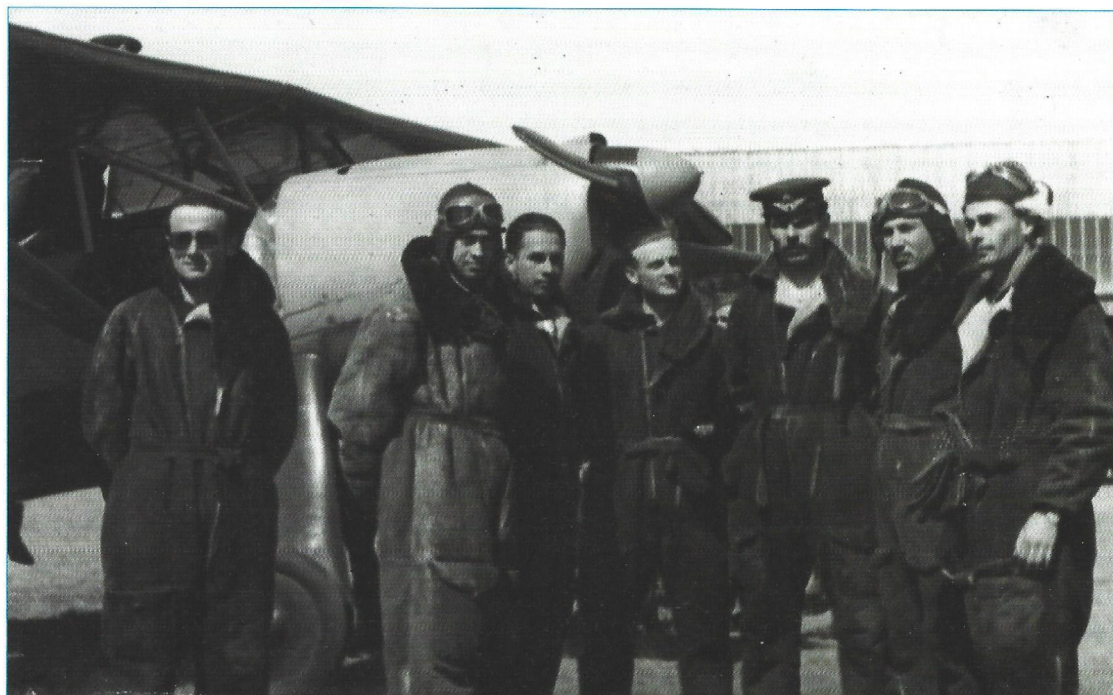
This is probably the last known photo of a Fw 56 with the so-called 'Tsarist roundel' type of military marking. Luckily, the precise date and location were recorded on the print: Karlovo airfield, 12 March 1940. At left, the aircraft type is also given: Komar. A couple of Arado Ar 65Fs are visible in the background.

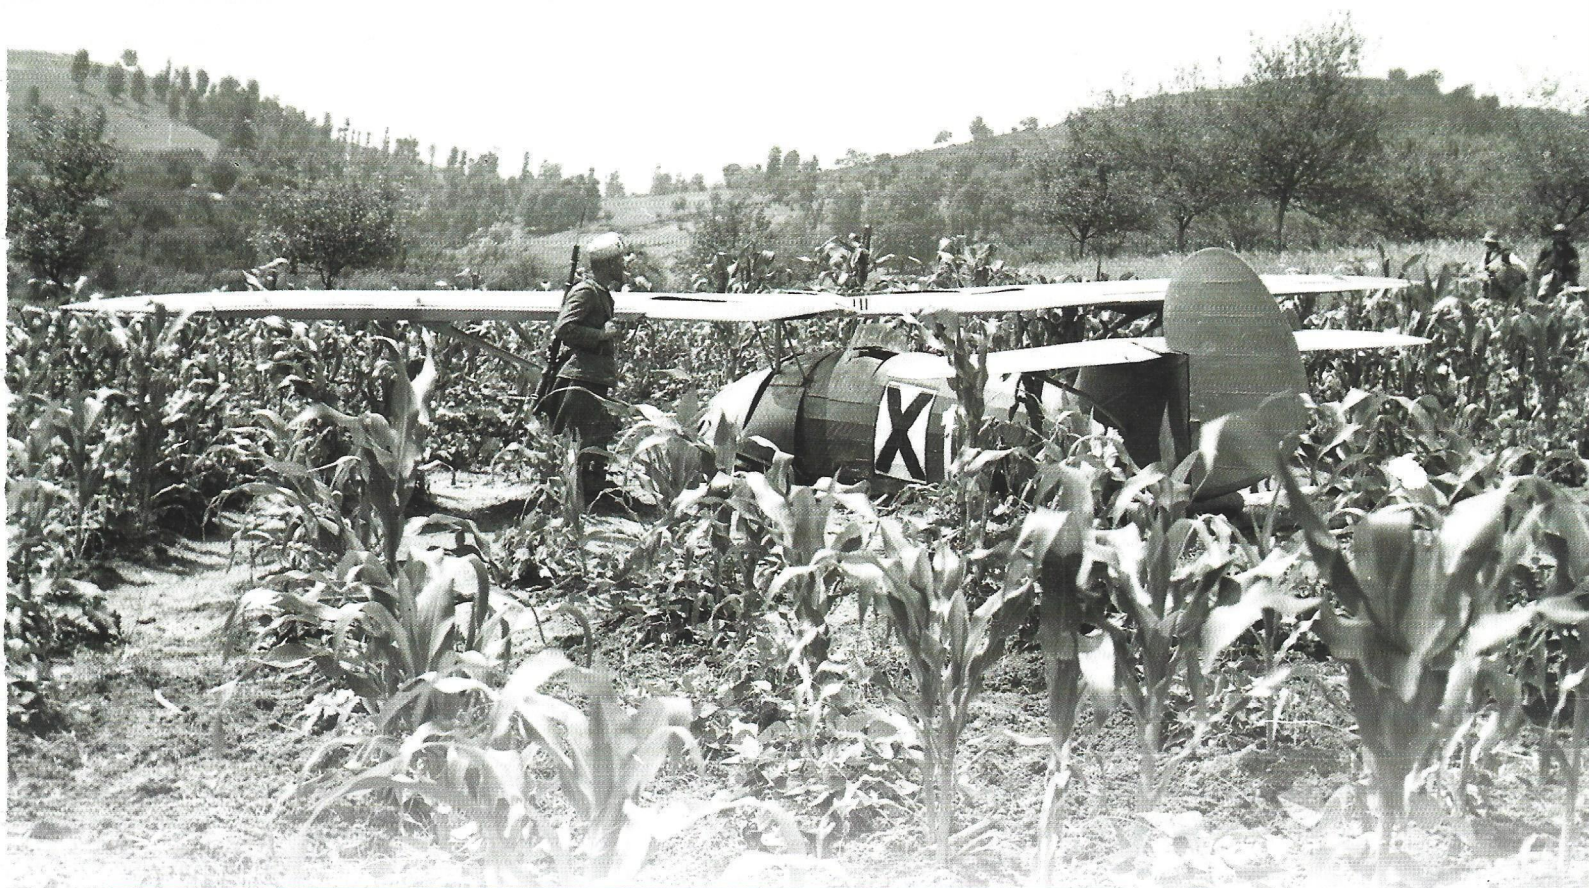
This photo, scanned from an original negative from the Popganchev collection, shows Komar No. 1, which bellied in a maze field at an unspecified date.

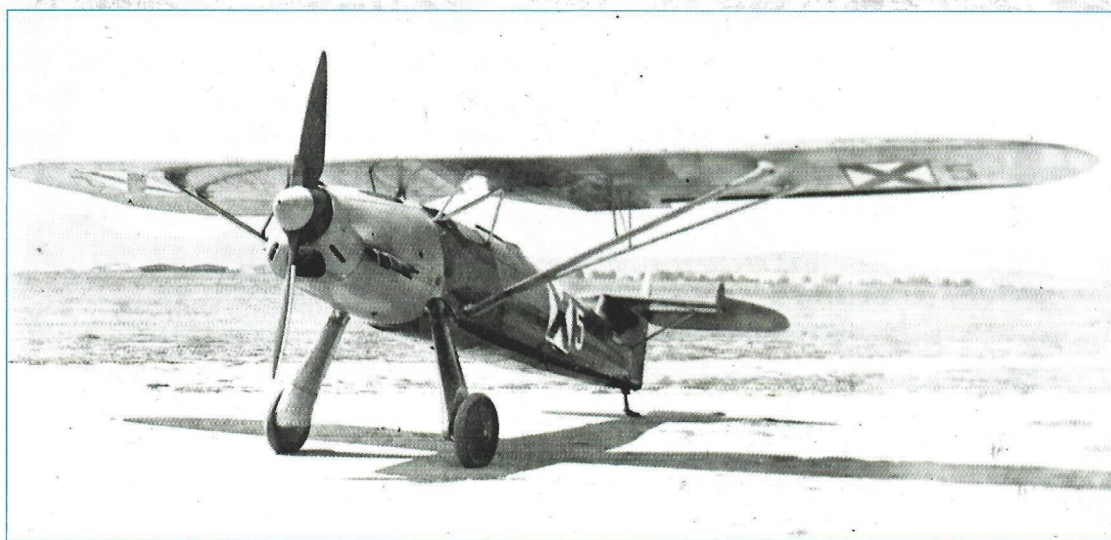
Three-quarter view of Fw 56, No. 5. This time, the flash along the fuselage is yellow.

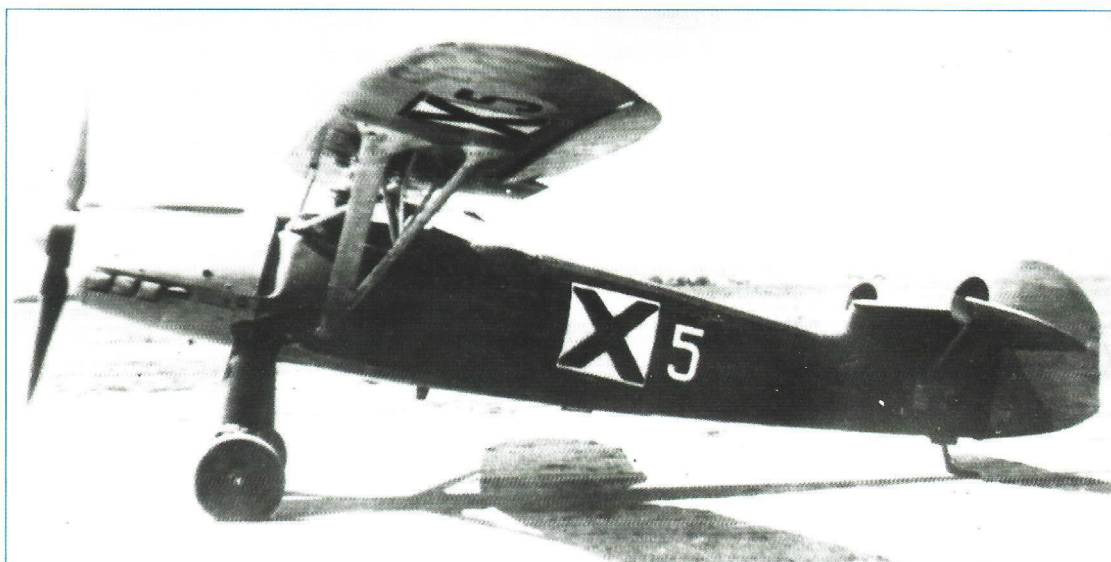
Silhouette study of the port side of the same machine, No. 5, taken sometimes in April-May 1941. At this time, the fuselage flash was painted in Axis yellow. This particular Fw 56 was the last one to soldier on until beyond the war's end.

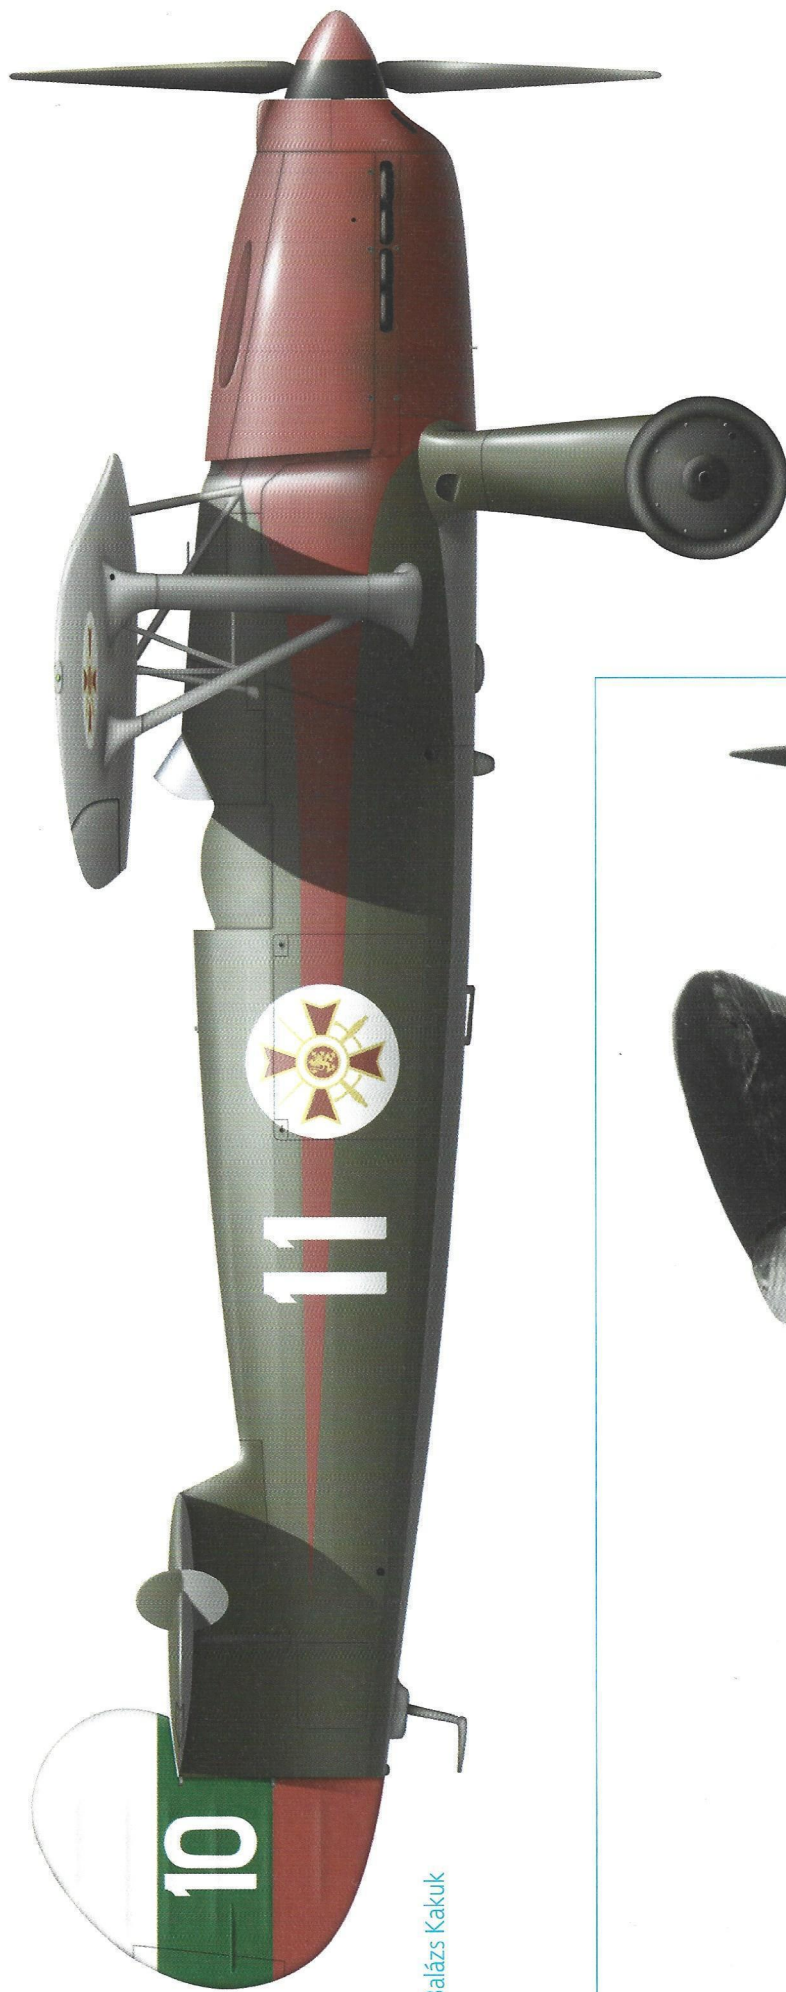
Balázs Kakuk

Focke-Wulf Fw 56A-1 Komar, 11-10, pilot Kpt. Ivan S. Ivanov, Bozhurishte airfield, 1 February 1937. Camouflage colours: Dark Green upper surfaces, Light Blue under surfaces. Roundel-style national marking in six positions. Rudder in Bulgarian tricolour (White, Green, Red). Red wrap-around engine cowling and fuselage flash. Spinner Black/Red.

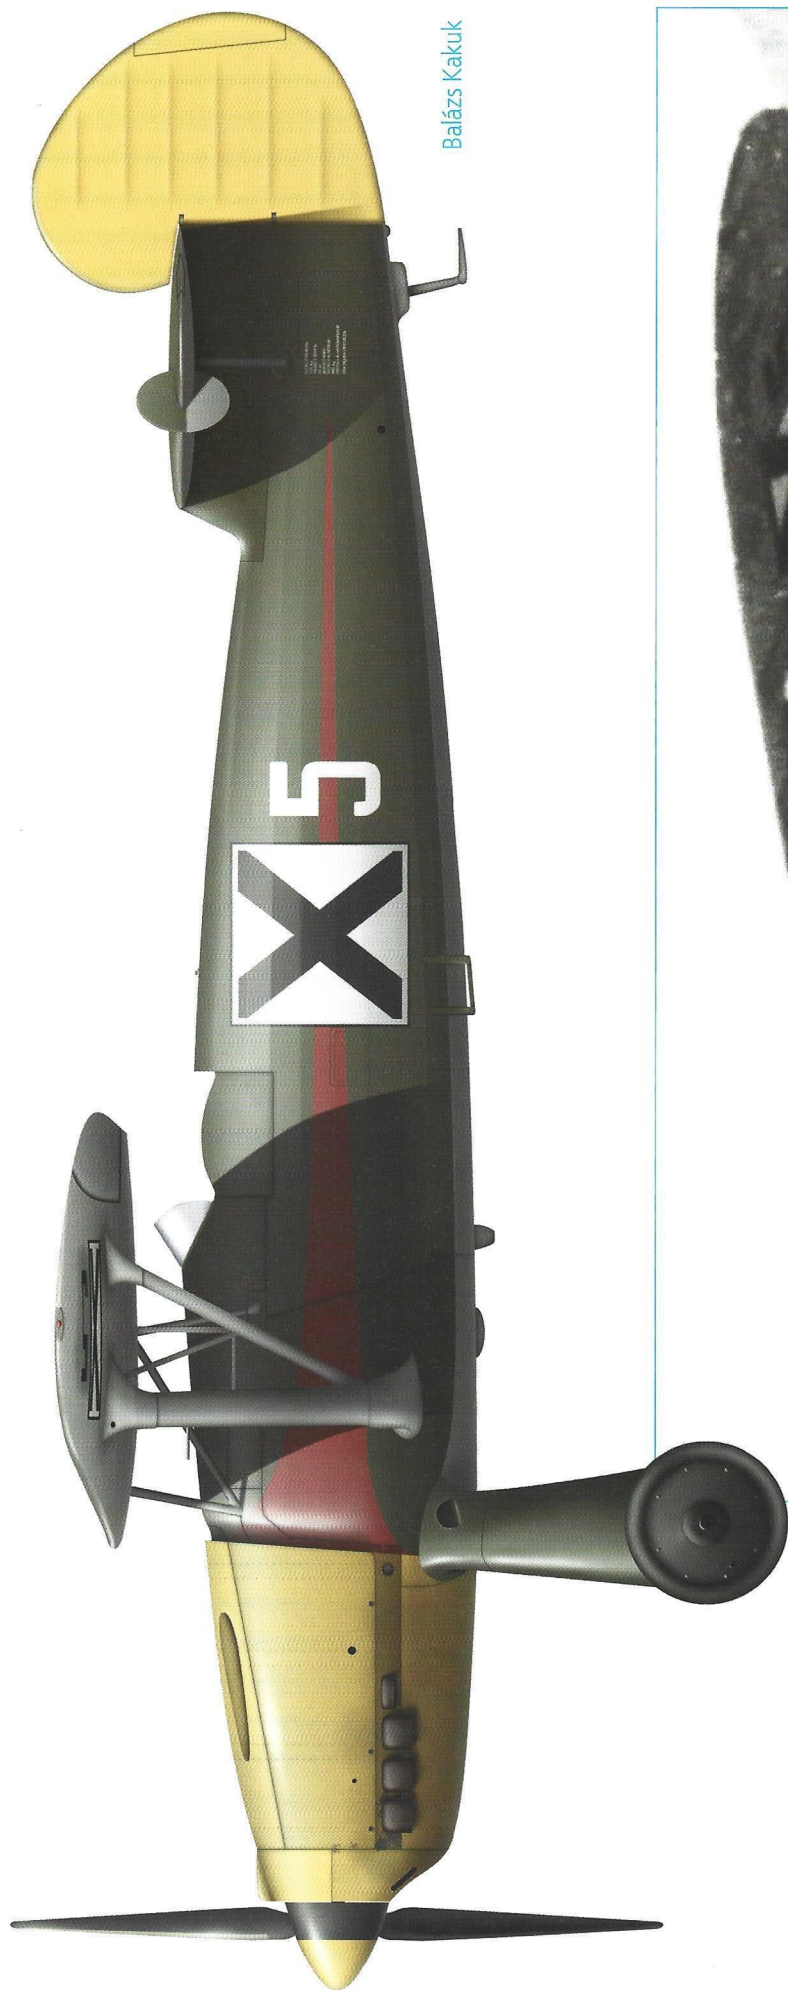
Fine silhouette study of the starboard side of Fw 56A-1, 11-10, which reveals the VNV markings and codes used in the early phase of service. Another, better quality, view of the port side of the same aircraft can be seen on pages 139 and 142.
